Safeguard Home Inspection, Inc.
Presents Your Exclusive
HOME INSPECTION REPORT

(address deleted)
Roswell, GA 30075
November 4, 2011

Inspector: Rob Golden

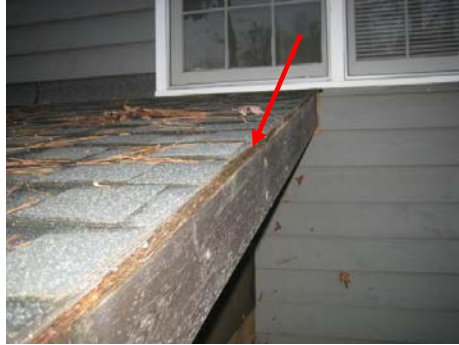
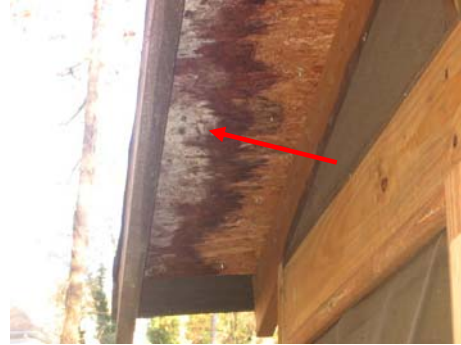
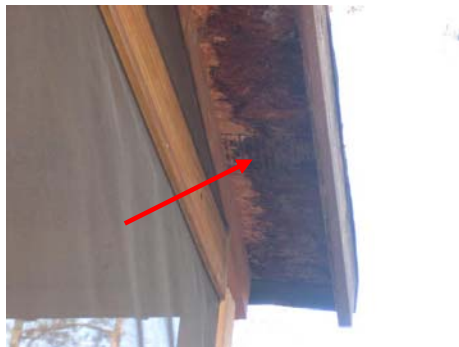
The roofing shingles above the covered deck do not have the necessary overhang at the edge (SEE PHOTO). This condition has caused moisture exposure and damage to the edge of the decking boards (SEE PHOTOS). Recommend replacement of damaged decking boards and installation of metal drip edge flashing at the enclosed deck by a qualified roofer.

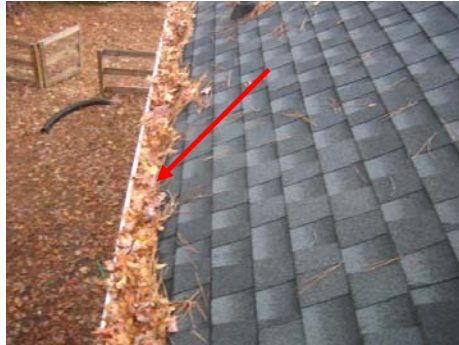
The gutters are filled with leaves (SEE PHOTO). Recommend cleaning gutters.

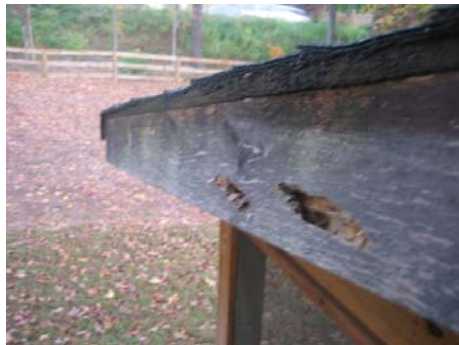
A small area of wood rot is noted at the fascia board on the west side of the covered deck (SEE PHOTO). Recommend repair or replacement of damaged wood.

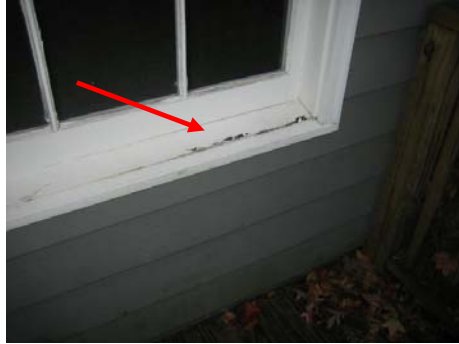
A small area of early-stage wood rot is noted at the window sill at the west side of the deck (SEE PHOTO). Recommend repair or replacement of damaged wood at window sill.

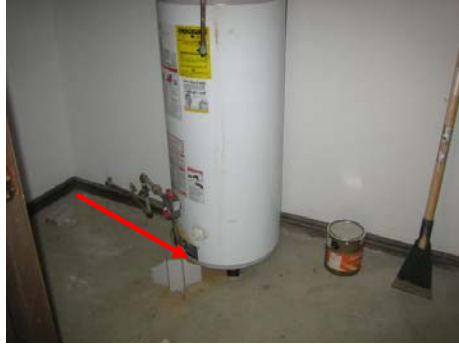
The water heater is sitting at floor level in the Garage (SEE PHOTO). This condition may allow flammable gasses which hover near ground level to come into contact with the burner. Recommend elevating water heater at least 18 inches above the floor level in Garage by a qualified plumber.

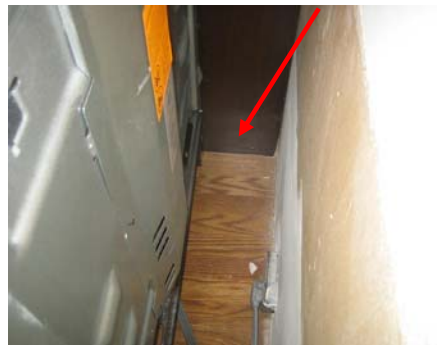
An anti-tip bracket is noted missing at the rear leg of the oven (SEE PHOTO). This condition may allow the oven to tip forward when the door is open and pressure or weight is applied. Recommend installation of an anti-tip bracket at the rear leg of the oven.

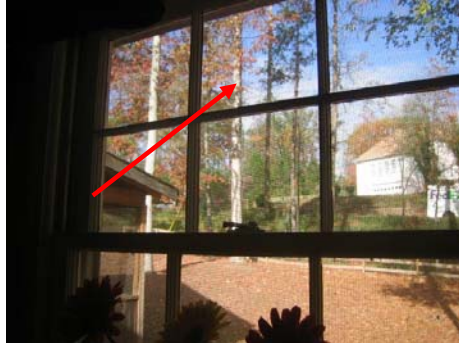
A cracked pane is noted at the window above the Kitchen sink (SEE PHOTO). Recommend replacement of cracked window pane.

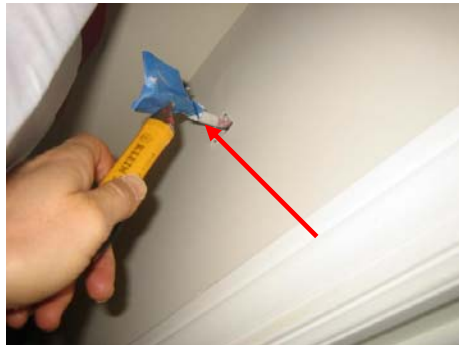
Improperly-terminated hot wiring is noted at the wall above the Kitchen sink (SEE PHOTO). This wiring is intended for a light fixture. Recommend installation of light fixture or removal or wiring by a qualified electrician.

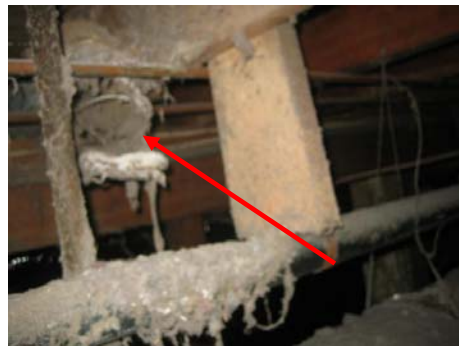
The Laundry Room dryer duct is terminating inside the Crawl Space (SEE PHOTO). Recommend extension of dryer duct to the exterior vent.

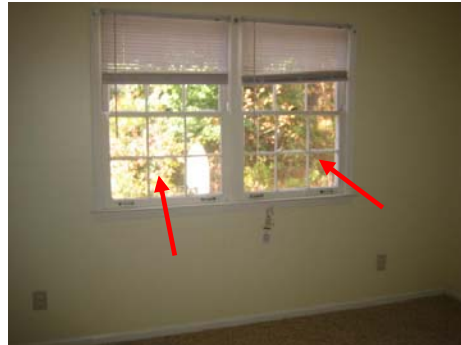
Both windows in the Second Floor West Bedroom are stuck/painted shut (SEE PHOTO), as well as the left-side window in the Second Floor South Bedroom and several other windows throughout the home. In a bedroom this condition is considered an egress safety concern that may hinder quick escape during a fire or other emergency. Recommend taking measured to allow for proper operation of all windows.

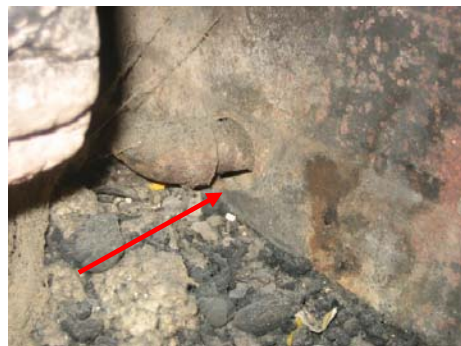
A small gap is noted where the gas line passes through panel inside the fireplace (SEE PHOTO). This condition may allow excessive heat or flames to draft through the opening and come into contact with flammable material. Recommend sealing gas where gas line penetrates through fireplace with an appropriate caulk product.

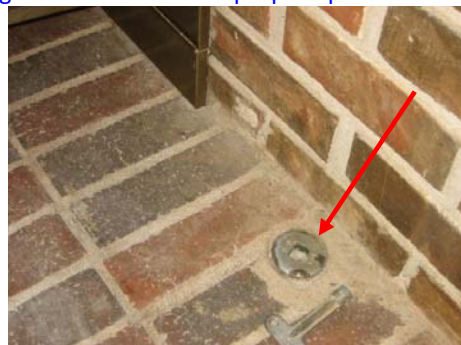
The gas valve at the fireplace cannot be turned due to the presence of debris (SEE PHOTO). Recommend clearing debris from exterior of gas valve to allow for proper operation.

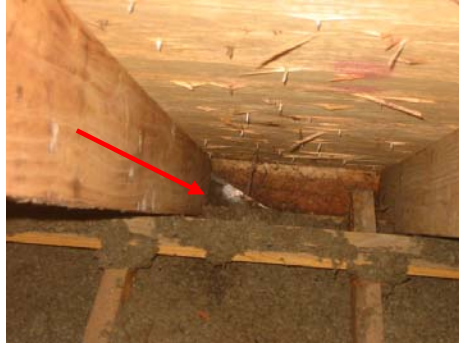
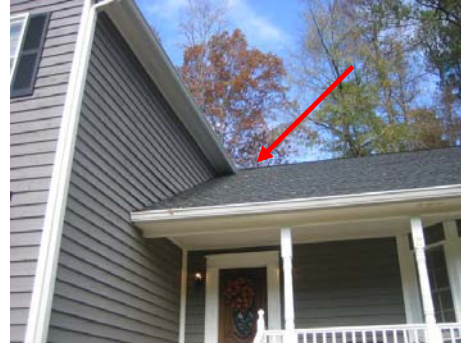
A small construction gap is noted in the Attic at the eave where the perpendicular roofs meet at the center of the home (SEE PHOTOS). This opening may allow pests to enter. Recommend sealing construction gap.

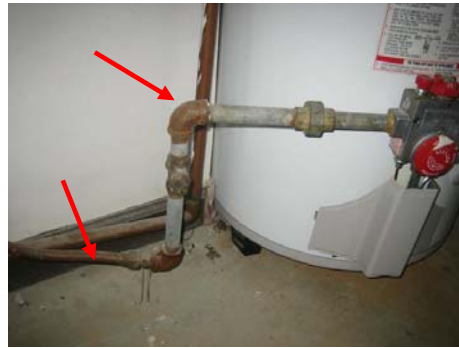
Dissimilar metal is present at the gas line serving the water heater and a drip leg at the gas line is missing (SEE PHOTO). The use of copper and galvanized steel on the same gas line will create an electrolytic reaction that causes debris to form. A drip leg is intended to capture debris in the gas line to prevent damage to the water heater. Recommend installation of an appropriate gas line and drip leg at the water heater by a qualified plumber.

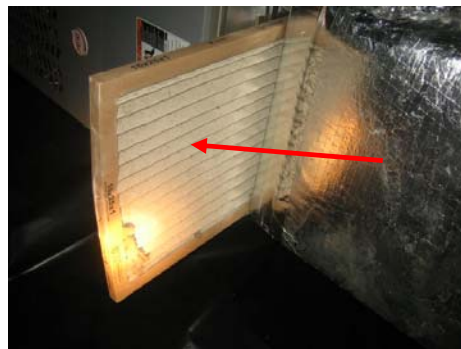
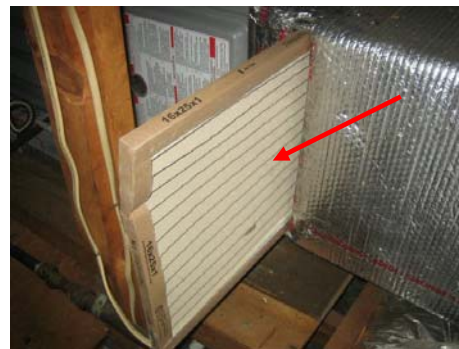
Dirty filters are noted at both air HVAC systems (SEE PHOTOS). Recommend replacement of filters.
